## Home Inspection Report

1234 Imagine Home Inspections Cleveland Ohio 44135  
Cleveland , Ohio 44135

# Imagine Home Inspections, LLC

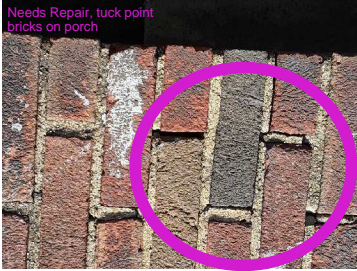
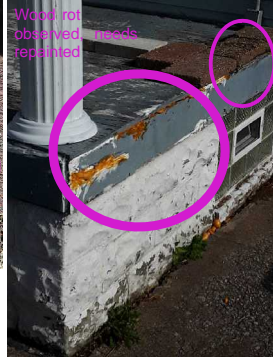
1. Driveway: Concrete
2. Walks: Brick
3. Steps/Stoops: Stone
4. Porch: Wood

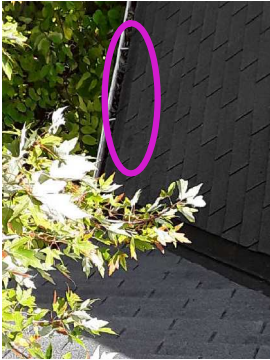
5. Patio: Paver
6. Deck: Stained wood
7. Balcony: Concrete
8. Grading: Moderate slope
9. Swale: Flat or negative slope, Pooling due to improper drainage
10. Vegetation: Trees hanging over roof - Will cause moisture on roof to dry slowly. This will lead to premature failure of roof surface

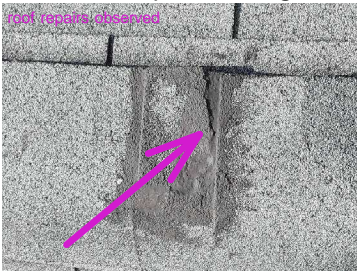
1. Method of Inspection: On roof
2. Unable to Inspect: 10%
3. Material: Asphalt shingle
